**Your Building
Condominiums**

Your Address
Seattle, WA

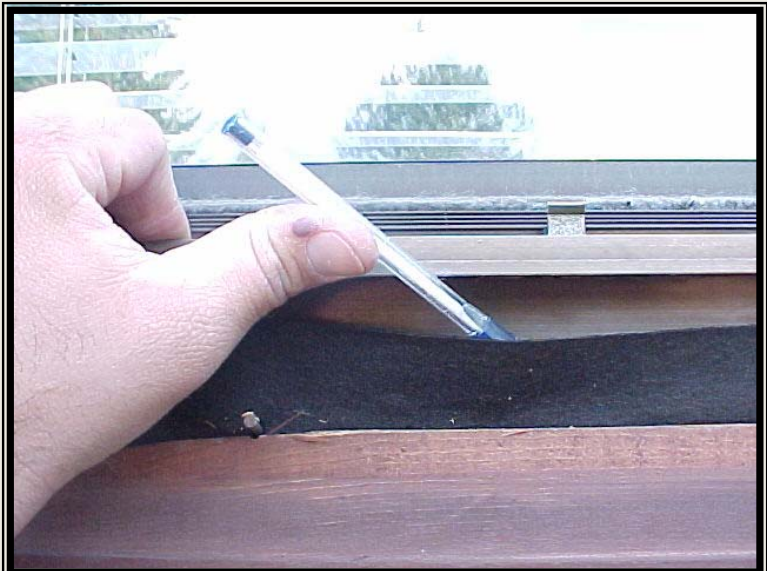
Building paper was found to be reverse-lapped on top of the nailing flanges at the bases of the windows. This could allow water to get behind the building paper at this location.

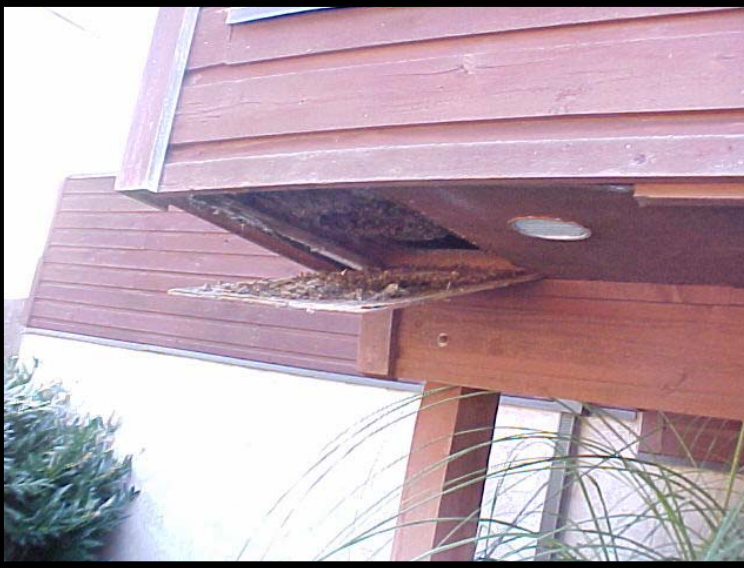
Tatley-Grund technicians located damage to the building paper, exterior gypsum sheathing, and framing members at the Unit 207 deck.

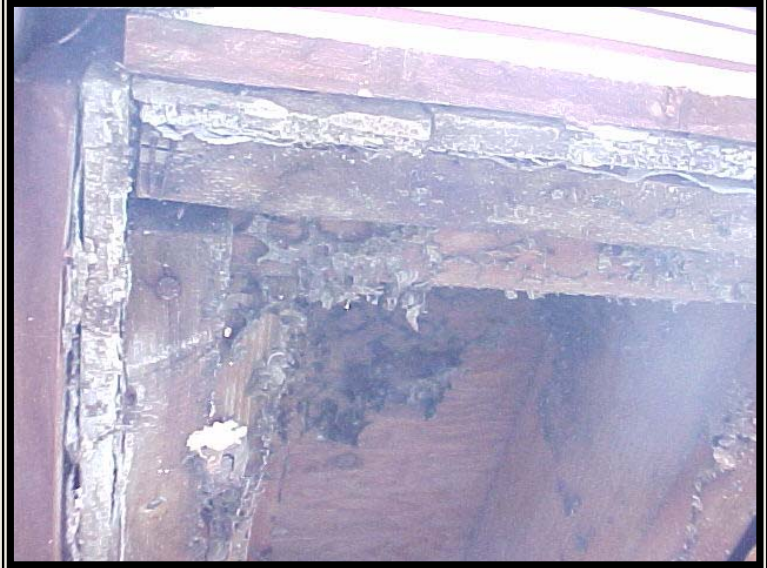
Water staining was present on the framing members, plywood decking below the topping slab, and gypsum sheathing as the plywood was removed from the soffit of the deck.

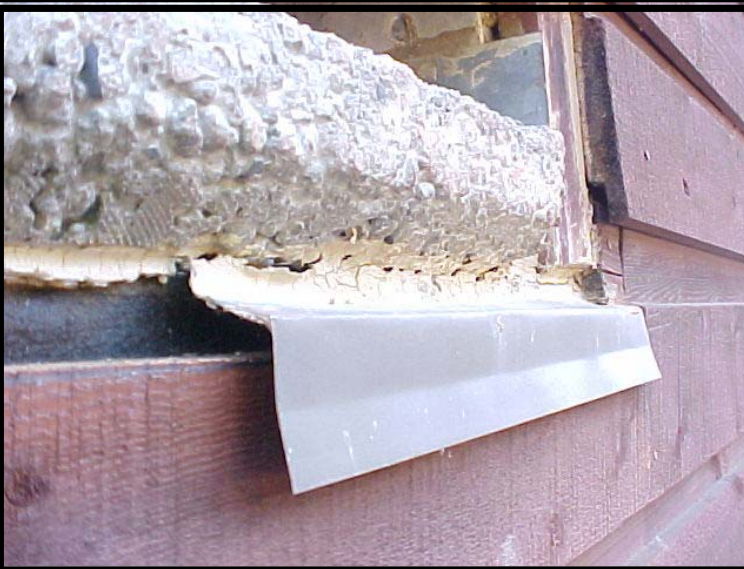
Flashings at the front edges of the decks do not tie into a membrane below the topping slab, but rather are caulked to the face of the slab. This sealant displays multiple points of failure.

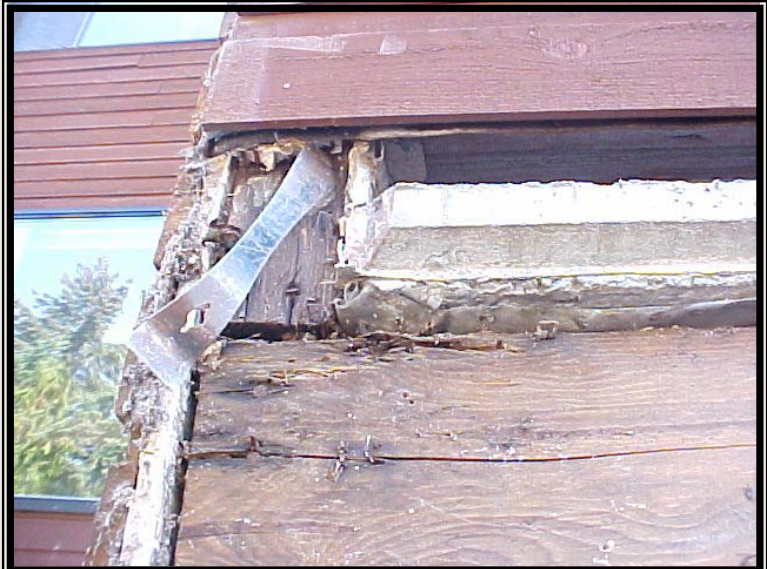
Decay was observed in the post and the rim joist of the deck as the exterior gypsum sheathing was removed.

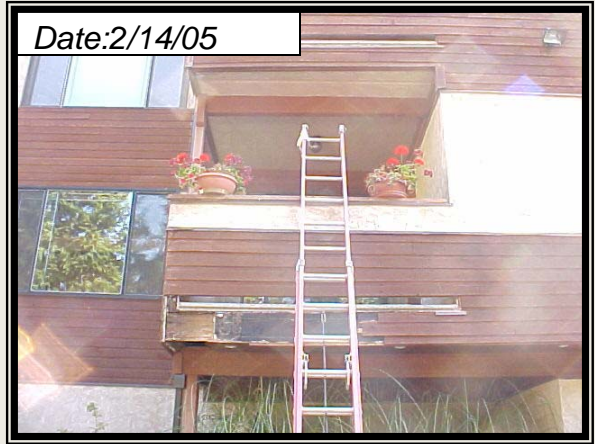
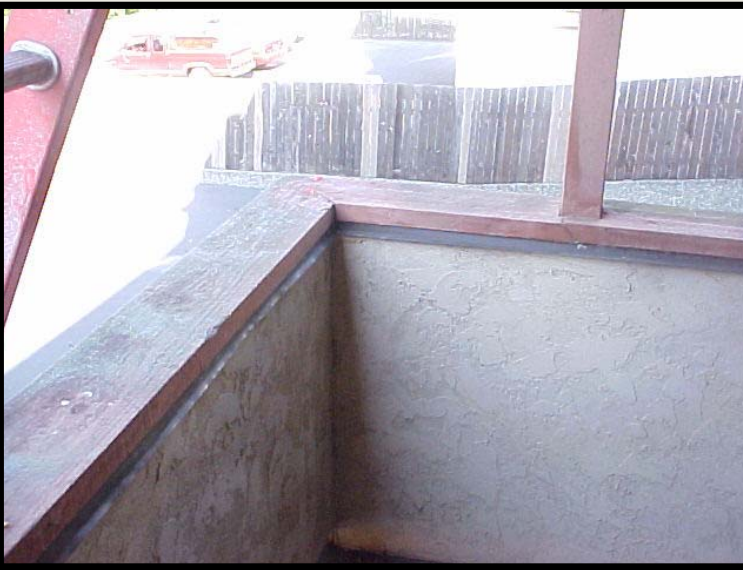
Above the damaged post and rim joist shown on the previous page, the mitre joint in the corner of the wood parapet cap is unsealed and there is no metal parapet cap flashing present.

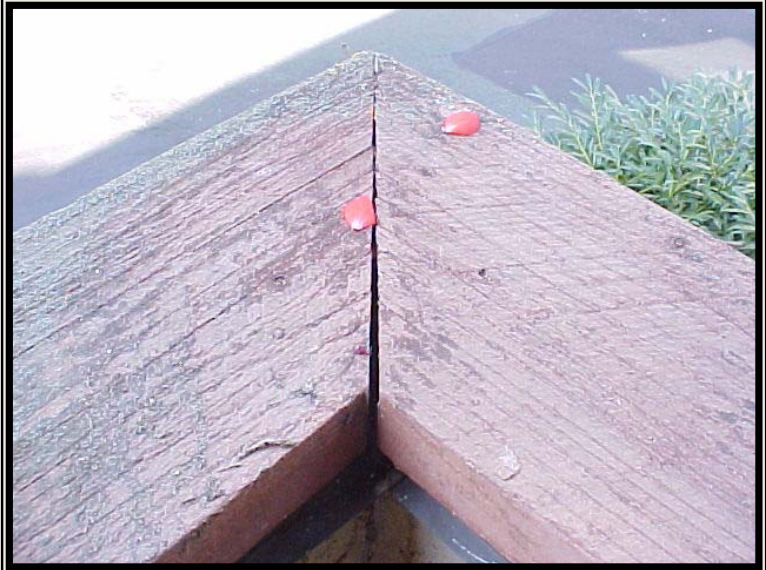
The mitre joint in the wood parapet cap is unsealed.

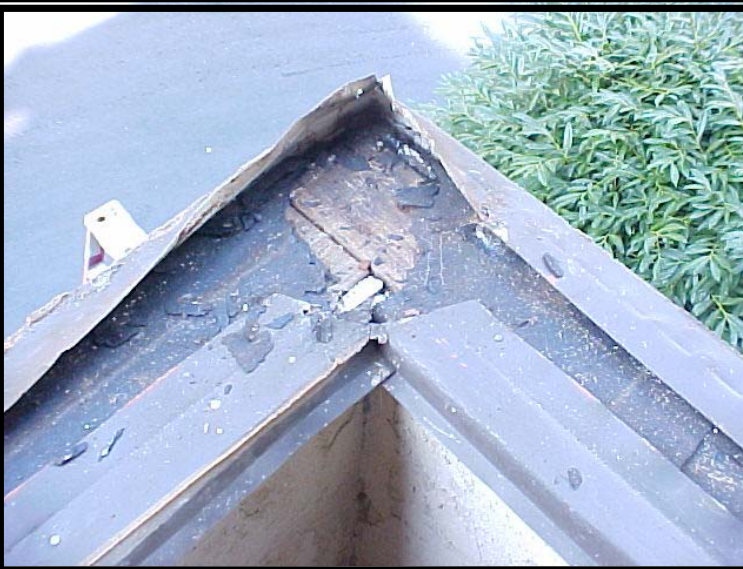
Water damage is present on the top plate of the parapet wall below the wood cap at the corner of the deck.

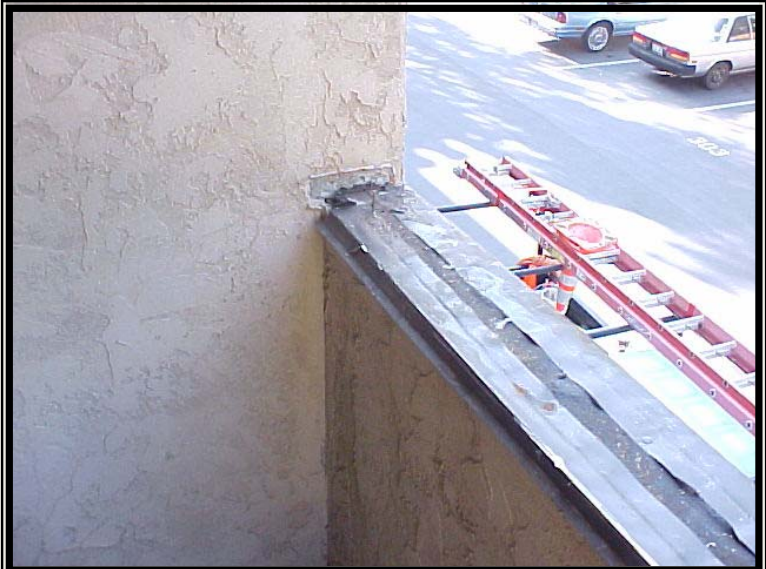
There are no boot flashings present where the deck parapet walls interface the vertical stucco walls. Water damage to the top plate of the parapet wall is present at this transition.

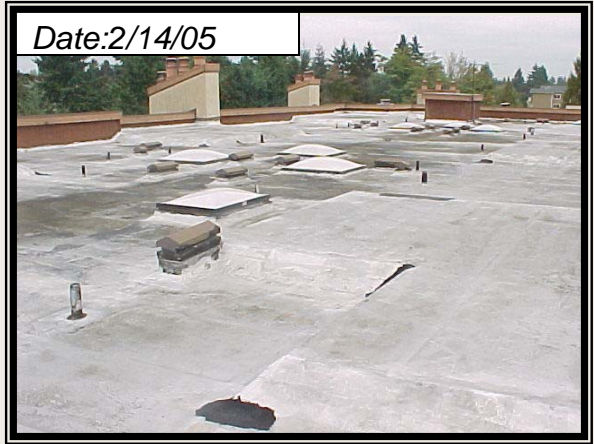
INVESTIGATION FINDINGS FROM:

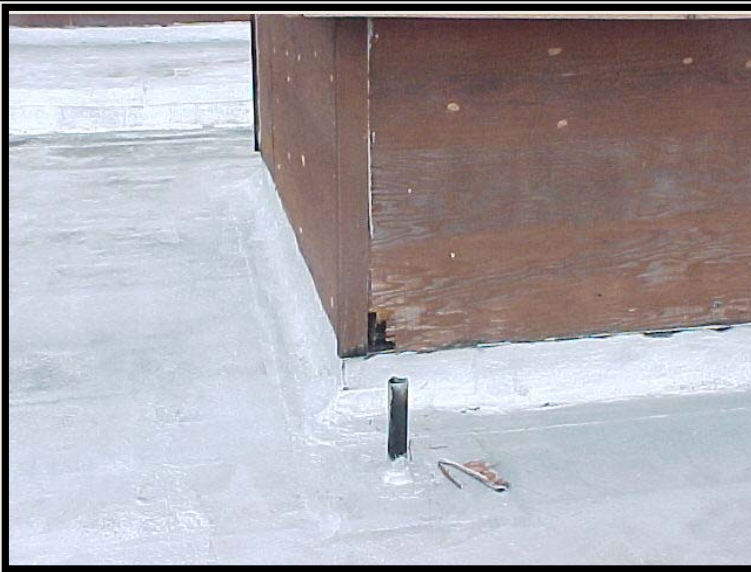
The upturned edge of the roofing membrane is exposed at this location. The building paper from the wall of the housing does not overlap the membrane and the plywood at this corner is deteriorated and decayed.

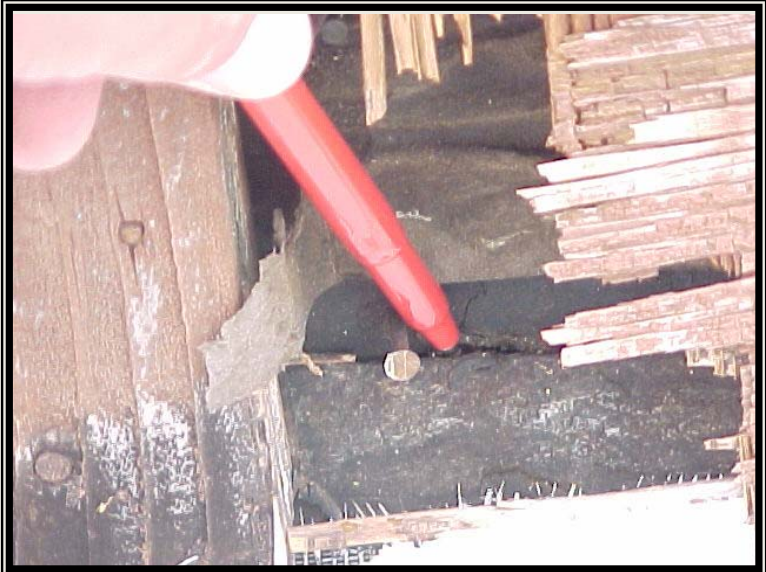
The upturned edge of the roofing membrane is exposed at this location. The building paper from the wall of the housing does not overlap the membrane and the plywood at this corner is deteriorated and decayed.

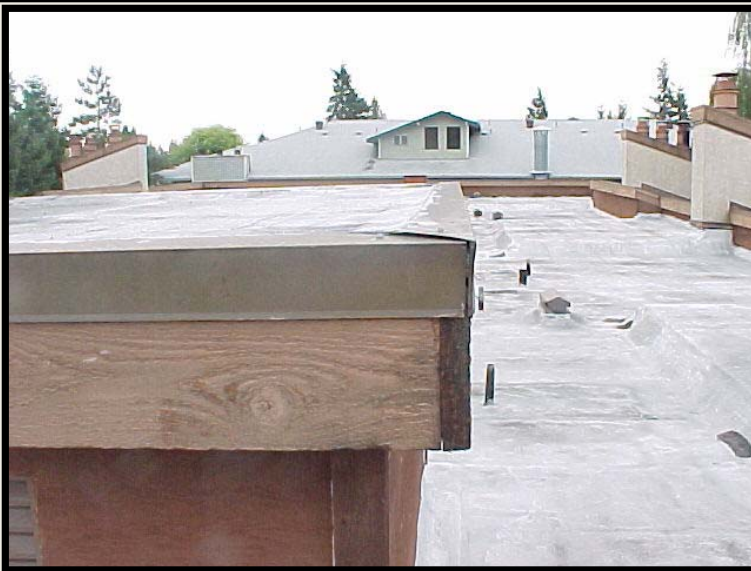
The corners in the coping on the elevator housing do not overlap, leaving an opening and potential opportunity for water intrusion.

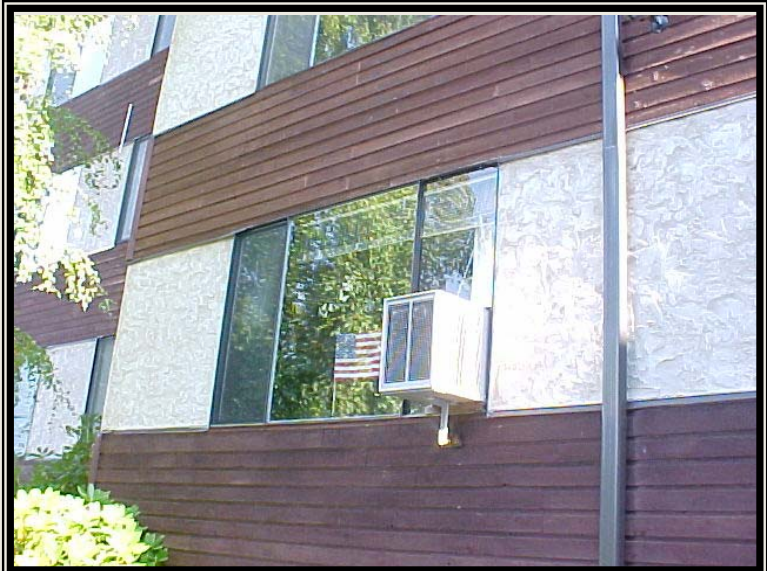
The windows in place at the Your Building Condominiums have no true expansion joint between the stucco cladding and the window frame. The perimeter is sealed however, and is observed to be in failure at every location reviewed.

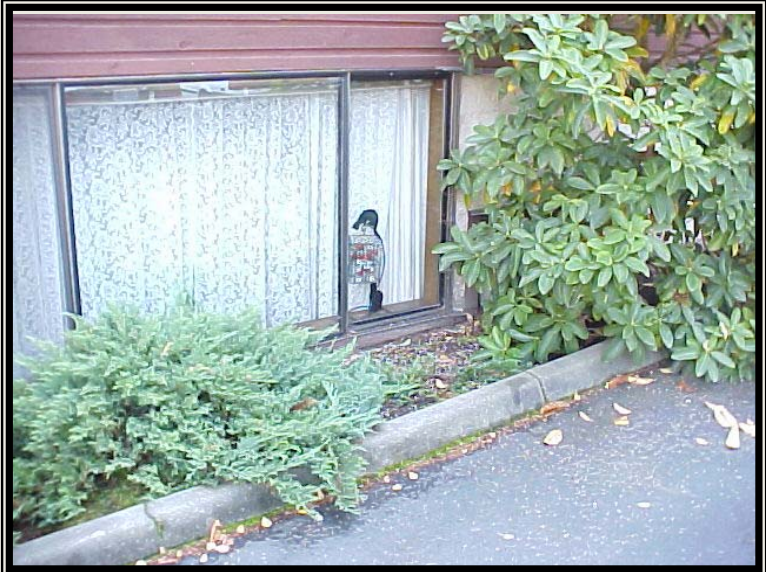
The wood trim at the sill of the window here is in contact with soil. This condition is causing the wood trim to rot/decay.

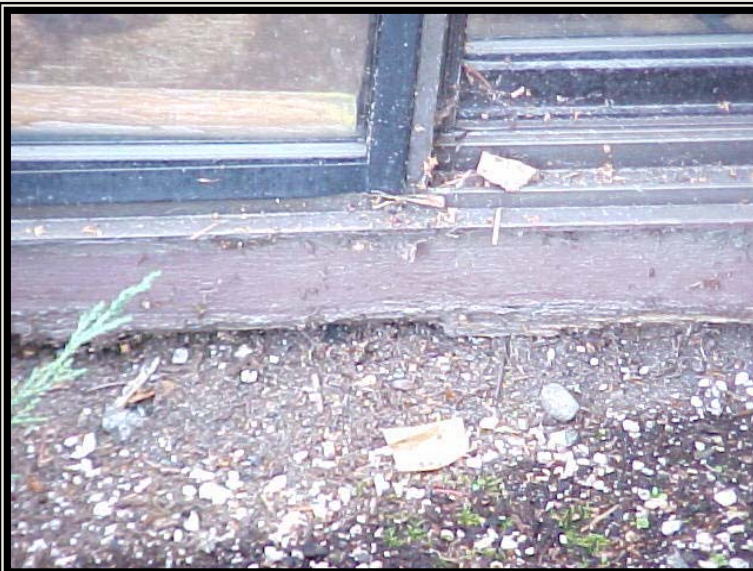
The wood trim at the sill of the window here is in contact with soil. This condition is causing the wood trim to rot/decay.

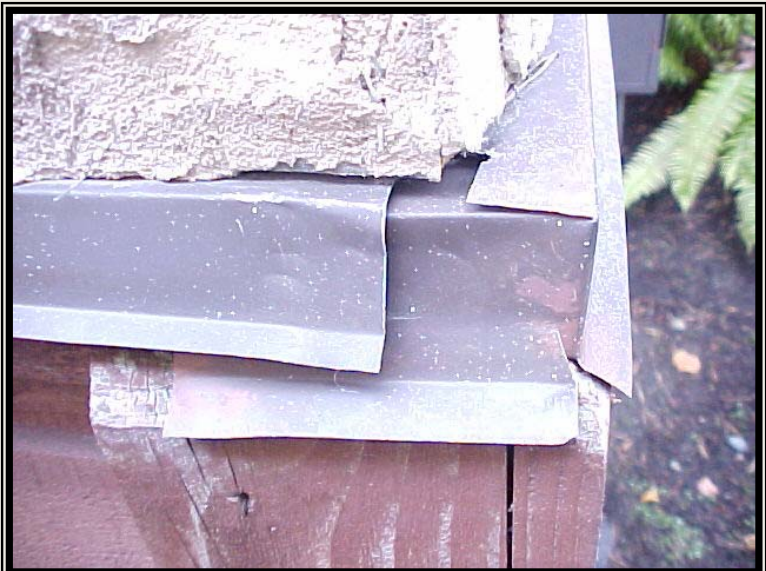
These seams in the flashing detail at the corner of the stucco outside unit 204 are unsealed and not fastened securely.
